**ENVIRONMENTAL IMPACT ASSESSMENT REPORT  
OF  
THE PROPOSED CONTAINER TERMINAL MODERNISATION PROJECT  
FOR  
KENYA PORTS AUTHORITY**

**MAY 2007**

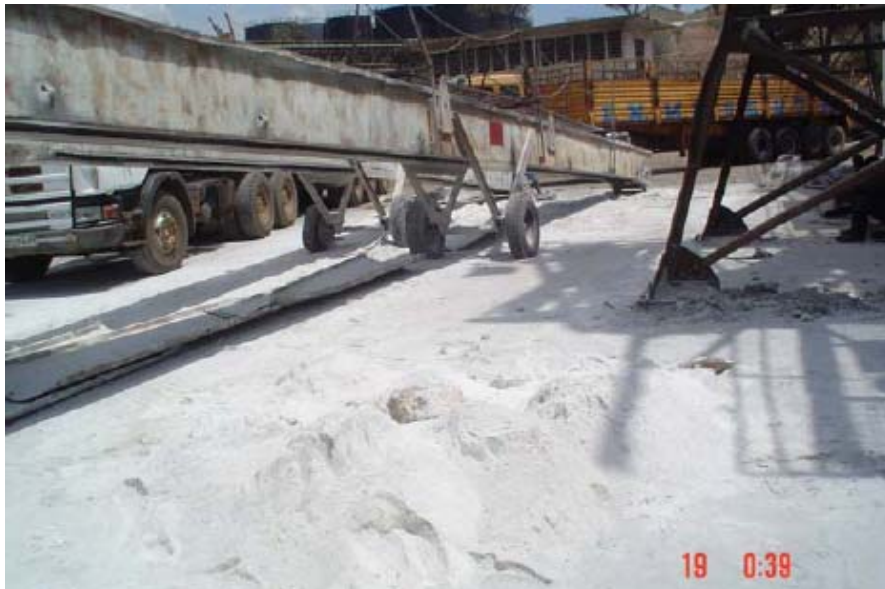
Figure 1.1: Spill of soda ash from Magadi Soda conveyor belt

*Dry Cargo releases:* There have been complaints of excessive dust releases during offloading of coal or clinker (for Bamburi Cement), soda ash (Magadi Soda, Fig 1.1) and occasionally during discharge of bulk grain (Grain Bulk Handlers Ltd). Some of the material finds its way into the ocean raising the Chemical Oxygen Demand (COD) to levels that may not be conducive for the survival of marine life.

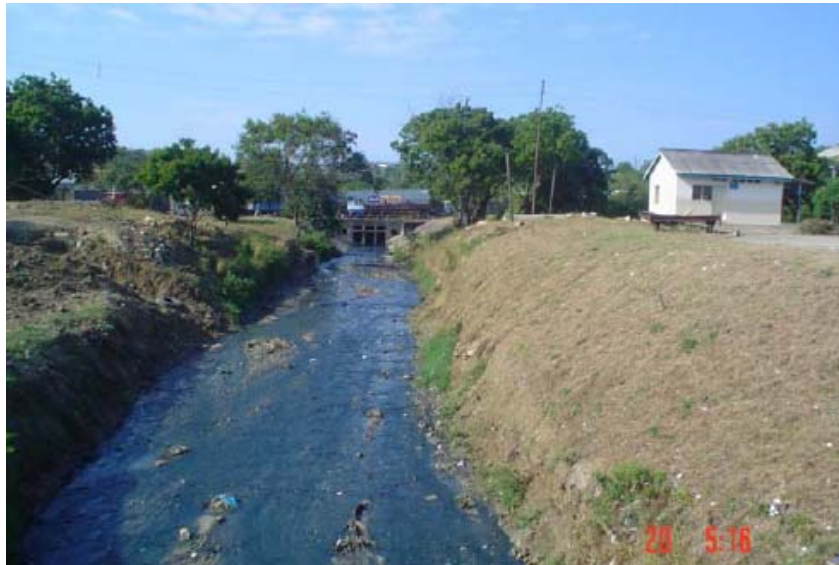
Figure 1.2: Untreated effluent from Municipal treatment plant discharges to sea

*Water front industry discharges:* Industries in the neighbourhood of the port discharge untreated sanitary and industrial wastes into the sea. There is also effluent from the Municipal sewage treatment plant (Fig 1.2) that is currently not functioning, consequently discharging raw sewage into the sea. Unfortunately this situation still prevails.

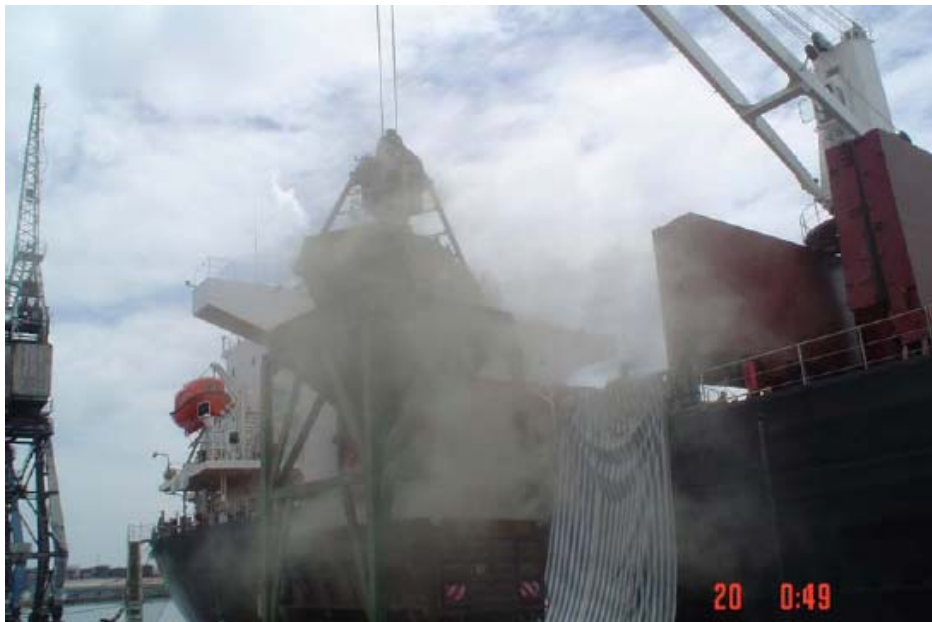
Figure 1.3: A grab discharging clinker into a truck

*Dry Cargo Releases:* As described above there is release of significant quantity of dust into the environment during offloading of dry cargo. Some of this is released as fine airborne dust, thereby lowering the ambient air quality standards. (See Fig 1.3)

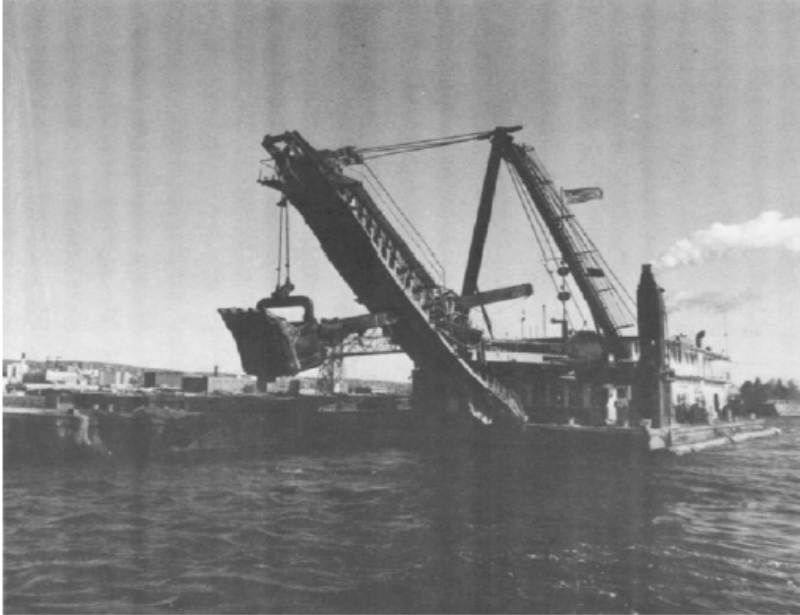
Figure.5.4: Dipper Dredge

dredges normally have a bucket capacity of 6 to 9 m<sup>3</sup> and a working depth of up to 15 m. There is a great variability in production rates, but 30 to 60 cycles per hour is routinely achieved.

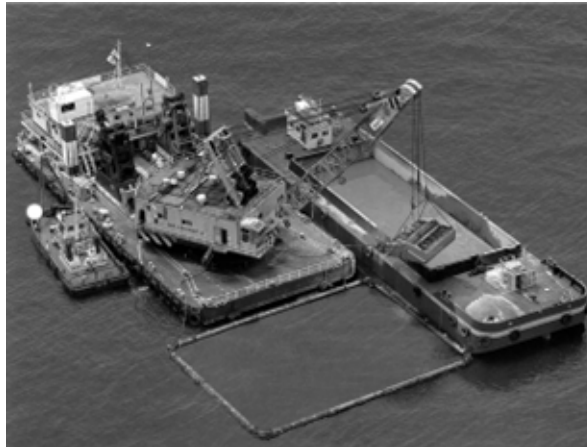
Grab Dredgers are non-propelled barges equipped with a mechanical grab hanged by a crane arm. The grab is dropped into the water to dredge bed materials. The dredged materials are loaded on a transport barge staying next to the dredger. The transport barges with fully loaded are transported by a tugboat to designated dumping location to discharge the loaded materials. Empty barges go back to the dredging site to load next dredged materials. Dredging capacity of the dredgers is widely available depending on the volume and materials to be dredged.

Fig 5.5: Grab Dredge (Contaminated Material Dredging)

In the event that the materials to be dredged have unacceptable levels of contaminants for open water disposal, the Grab Dredger with special special equipment (see Fig 5.5) will be most suitable.

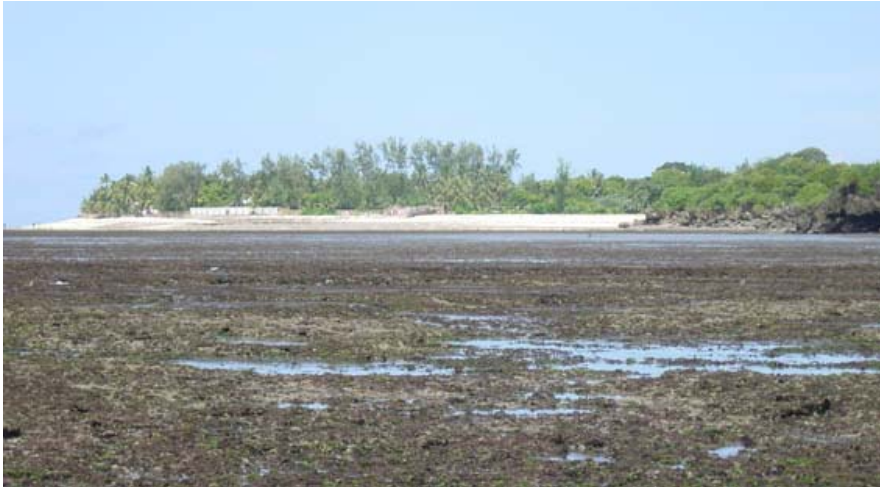
Figure 8.2: Shelly Beach at maximum spring low. The Intertidal reef flats as shown here correspond to areas marked green in Fig 2.2.

Figure 2.2 is marked in light green for shallow depths (less than 4 m datum depths), which also get exposed at maximum spring tides, and correspond to mudflats and mangroves (within the Port Reitz and Kilindini bay waters), and correspond to shallow lagoons, reef crests or reef flats and sandflats (within the Shelly Beach and Nyali Beach areas; Fig. 8.2).

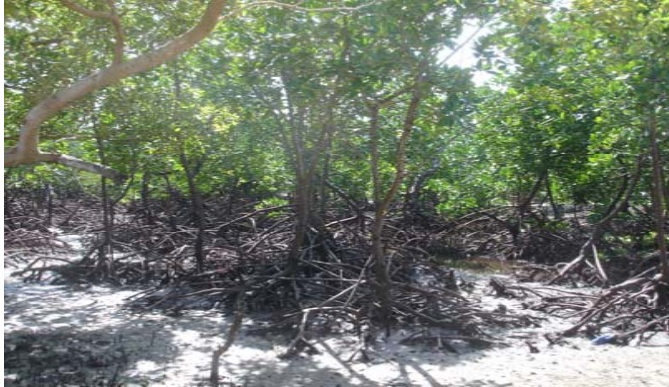
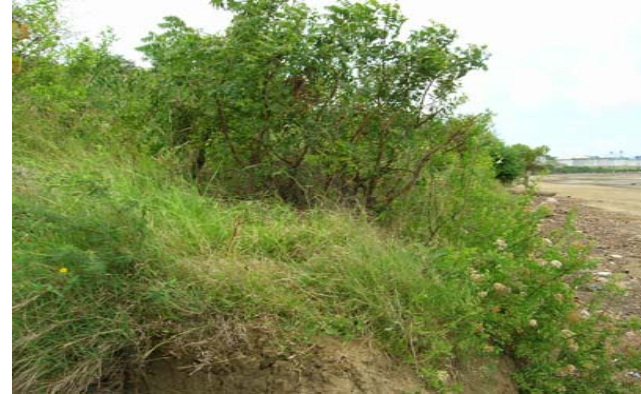
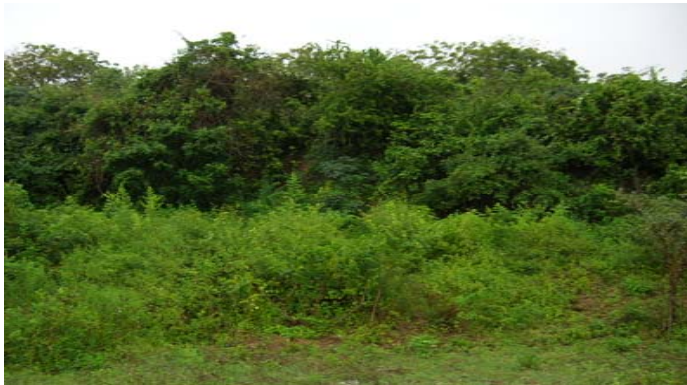
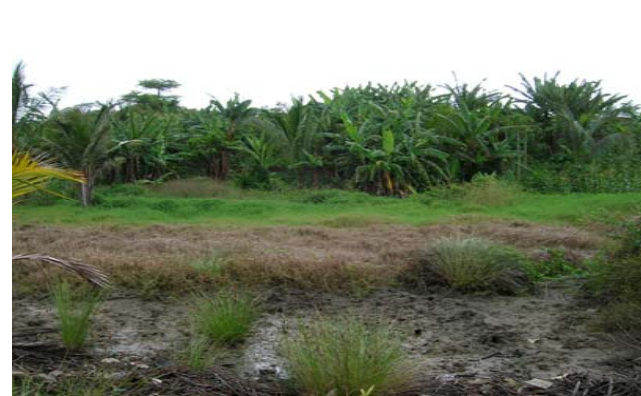
Mixed shrubs and grass vegetation on the banks of Port Reitz creek

Dry land tree and shrub thicket on the banks of Port Reitz creek

Man-made agricultural systems at Port Reitz creek

Figure 8.6: The main types of vegetation assemblage found along Port Reitz creek

Four types of natural vegetation assemblages and one for man-made vegetation (agricultural systems) were found in the Port Reitz creek, these are shown in Table 8.3 and Figure 8.6 below.

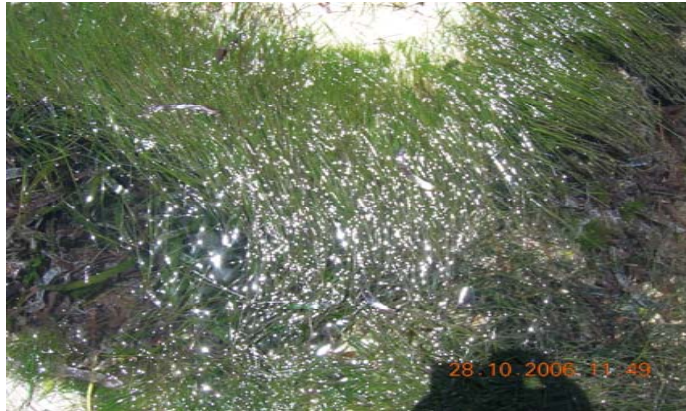
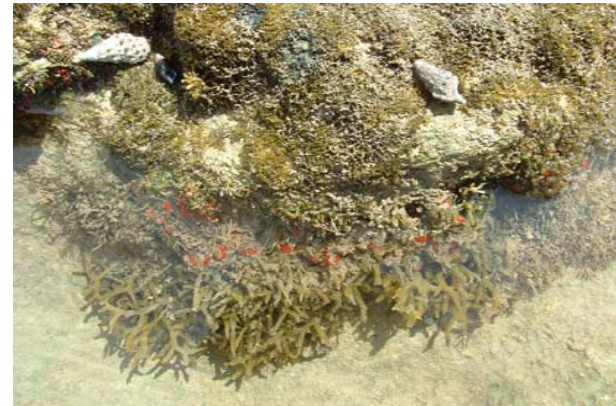
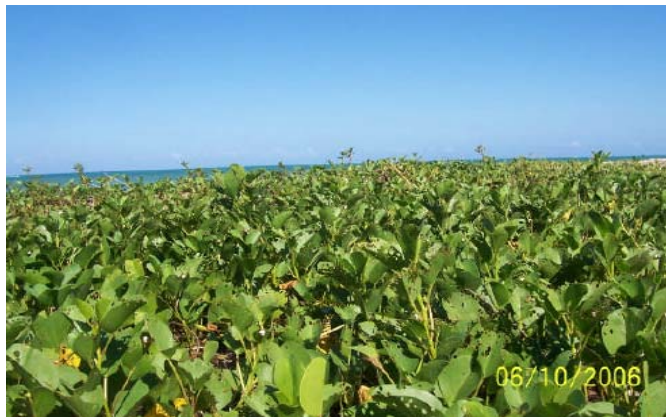
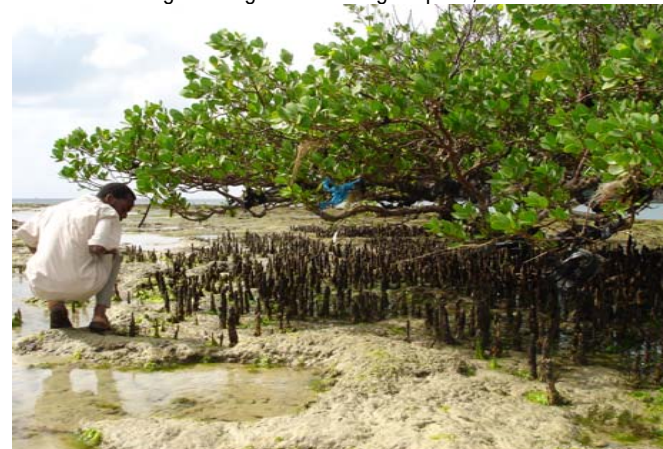
Sub-tidal seaweed vegetation (brown algae) at Shelly Beach

Beach rail-road vine vegetation at Shelly Beach

Sonneratia mangrove vegetation at English point, Mkonani

Figure 8.7: The main types of vegetation assemblage found around Shelly Beach and below right lone Sonneratia at Nyali's English point

Seven (7) species of true-mangrove plants and seven (7) typical species of mangrove – associates plants were encountered and are recorded (Table 8.4). There were no mangroves on the shelly beach area, though a relic of small mangrove was observed at the English point comprising mostly of *Sonneratia alba* (this survey Figure 8.7, Ruwa 1993). The community structure here was not investigated as they are far removed from the possible dredge/reclamation impact potential zones based on local knowledge of coastal flushing and hydrodynamics.

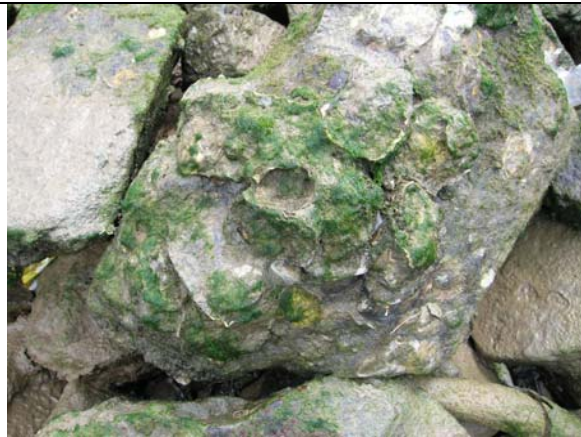
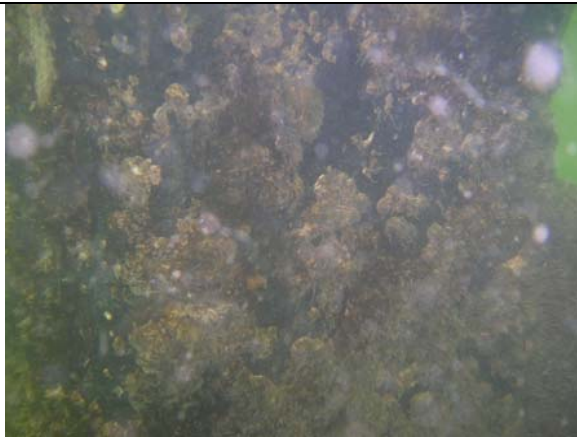
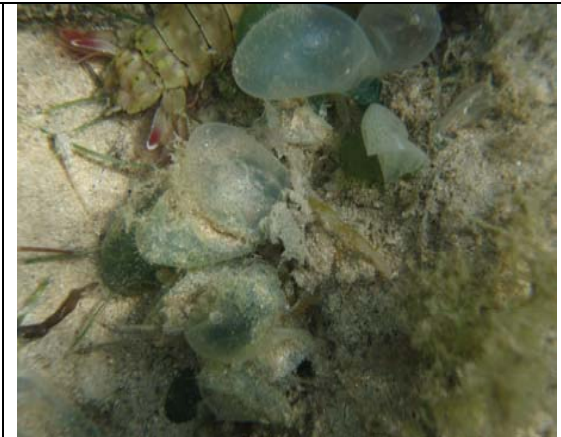
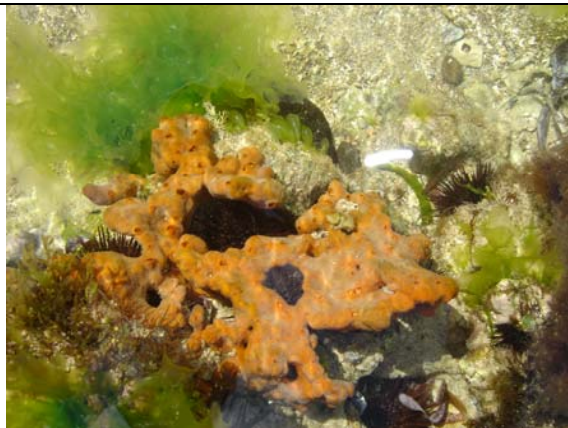
Oysters on concrete wall around Beth-19

Pits & depressions with benthos on seafloor of Port Reitz

Mixed benthos & slow sessiles on seafloor of Shelly beach

Sponges, seaweeds and benthic fauna at Shelly beach

These comprised the wide reef flats in front of the high-raised cliffs. Rocks in the upper part of intertidal zone had a sparse biological activity, with mostly unicellular algae and fleshy alga, and a fauna of chitons and limpets and some amphibian crustaceans. Some sub tidal rocks have developed a richer flora and fauna resembling the conditions found on coral reefs. In the survey areas, we did not get good coral life forms. Hard and soft corals were found in discrete patches, surrounded by algae and seagrass beds. Benthic invertebrates were seen varying in cover from zero to about 30% (mostly for sea urchin colonies) and some of these are presented in Fig. 8.18.

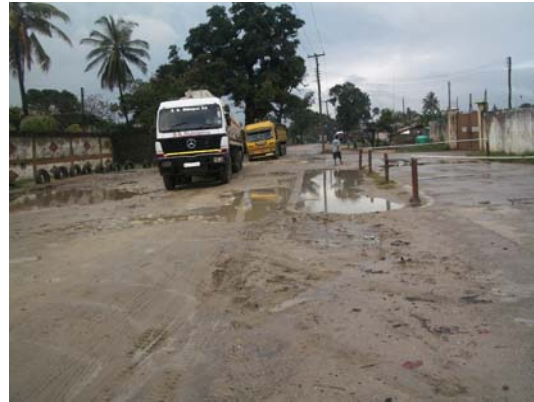
Plate 6: The Portreitz road in its current state.

The Portreitz-Kipevu-Kwahola area is served by van (*matatu*) services as the main mode of transport. This public transport however suffers from the poor condition of the road between Portreitz and Kwahola (see plates 5 and 6).

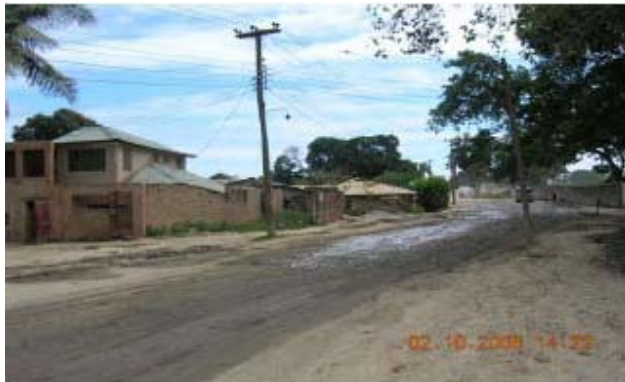
Plate 9: Electricity line running parallel to the dilapidated Portreitz road

The entire Portreitz-Kipevu-Kwahola area is served with electricity with the main electricity line running parallel to the Portreitz-Kwahola road (**see plate 9**).

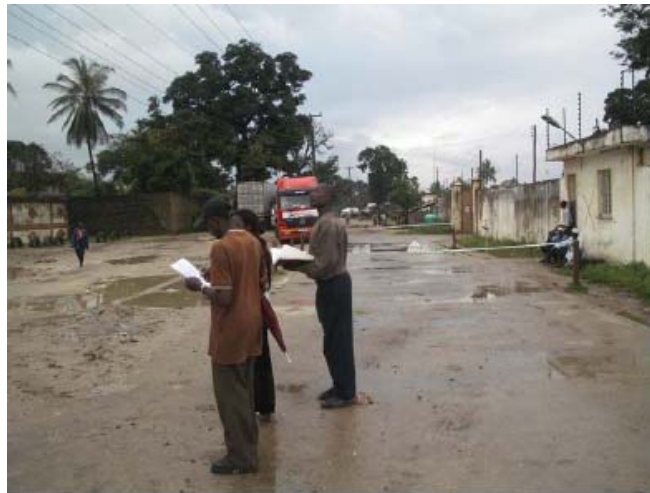
Figure 10.1: Traffic volume survey along Port Reitz road. Note the dilapidated state of the road

The project will result in more vehicular traffic, hence the increases and their impacts had to be evaluated. Land traffic survey was done from 20<sup>th</sup> to 29<sup>th</sup> September 2006 along the three roads likely to be impacted on by the project namely Port Reitz road, Airport road and Magongo road. As part of the assessment to the alternative proposal by Pacific Consultants International traffic survey was also done on Kenyatta Avenue at Kibarani on 31<sup>st</sup> October and 1<sup>st</sup> and 2<sup>nd</sup> November 2006. The traffic observation points are indicated in Fig. 6.1.

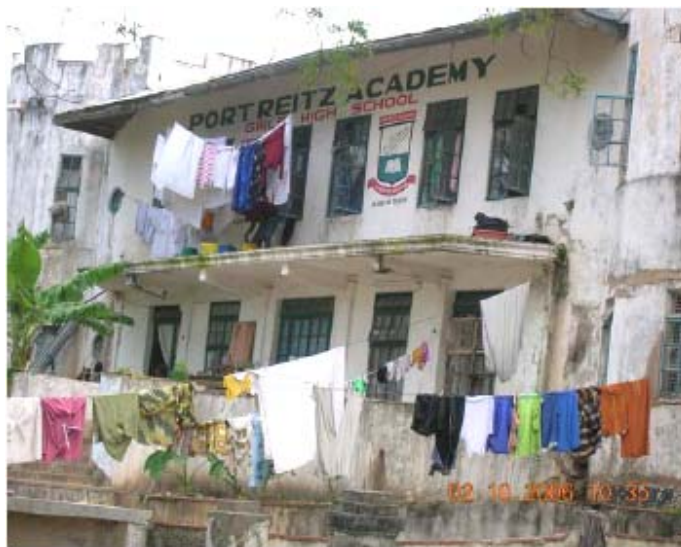
Former Port Reitz Academy currently being used as residential rental flat  
Is one of the structures to be affected

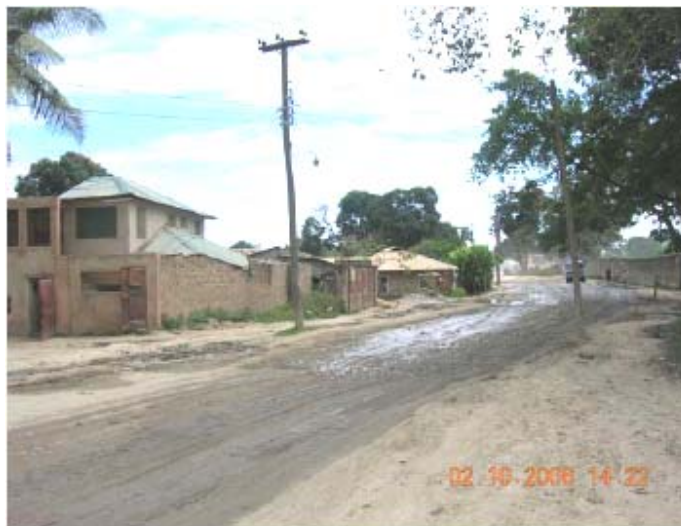
Power line along the entire road will have to be relocated

- Electricity line that runs parallel to the Port Reitz road may have to be relocated to create room for the proposed expansion of the current Port Reitz road.
